# ***In-Service Tests of the Effectiveness of Vibration Control Measures on the BART Rail Transit System***

**8th International Workshop on Railway Noise  
October 2007, Buxton, England**

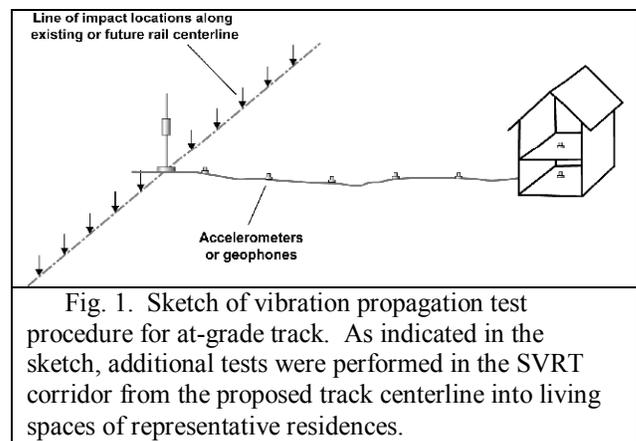
A primary goal of the testing was to isolate the true insertion loss of each mitigation measure. This is always problematical because of the difficulty factoring out effects of localized geology on the measured levels of train vibration. The approach taken was to measure both train vibration and transfer mobility using an impact vibration force at each test site. The test configuration for at-grade track is shown in Fig. 1. A line vibration source was simulated by impacts at regular intervals parallel to the track centerline. Ground surface vibration velocity (vertical direction) was measured with a line of transducers perpendicular to the track. As indicated in Fig. 1, a similar series of tests were performed along the

proposed SVRT corridor to measure transfer mobility from the track centerline into living spaces of adjacent residences. This procedure allows developing projected indoor vibration levels directly from the measurement results.

It is appropriate to make a few additional comments and observations about how these results will be applied to the SVRT project. Vibration propagation tests in the corridor using the procedures shown in Fig. 1 were performed at six representative residences. These measurements in conjunction with the force densities measured at the Hayward Test Track were used to predict future vibration levels inside living spaces of these residences. The testing confirmed that the proposed BART extension would be likely to cause vibration levels that exceed the Federal Transit Administration vibration impact threshold of 72 VdB (vibration velocity level using a decibel reference of 1  $\mu$ in/sec) at many residences in the SVRT corridor. The maximum vibration velocity is projected to be in the 12 to 25 Hz range inside five of the six residences that were tested.

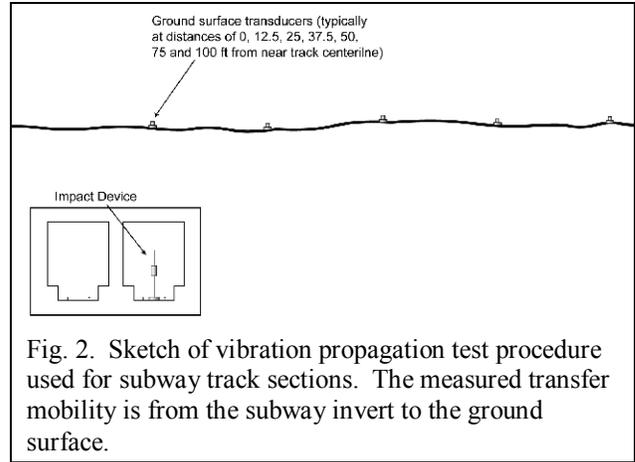
Fig. 2. Sketch of vibration propagation test procedure used for subway track sections. The measured transfer mobility is from the subway invert to the ground surface.

A similar test procedure was used for the subway test sections (Fig. 2) measuring transfer mobility from the subway invert to the ground surface. The measured point-source transfer mobilities for each line of impacts were combined to provide a line-source transfer mobility. For both the at-grade and subway tests we measured transfer mobility and train vibration using the same transducer locations. The vibration forces generated by the trains were then estimated using the following relationship for each 1/3 octave band:

As discussed above and shown in Fig. 2, the intention was to use impact testing to measure transfer mobility from the subway invert to the ground surface at all three test sites in the SFO subway. Unfortunately, as shown in Fig. 8, the floating slab is a continuous design with no access to the invert large enough to perform impact tests. This means that we have to use a comparison of measured ground-surface vibration levels to infer how effective the floating slab is at reducing vibration levels.

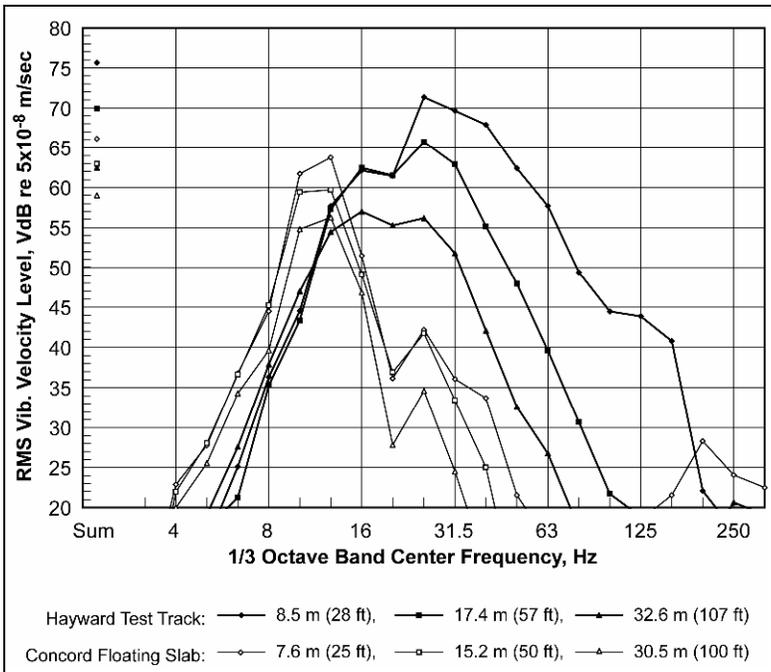
Fig. 3. Average vibration levels measured at Hayward Test Track and Concord floating slab. Average train speed was 65 mph at for both sites.

The tests for at-grade track consisted at controlled speeds with a special test train at the Hayward Test Track and measurements of the revenue service trains at the Concord floating slab. Fig. 3 shows the average 1/3 octave band spectra for three similar distances measured from the track centerline at train speeds of 65 mph. This figure suggests that the floating slab track is dramatically reducing the vibration levels at frequencies of 16 Hz and higher.

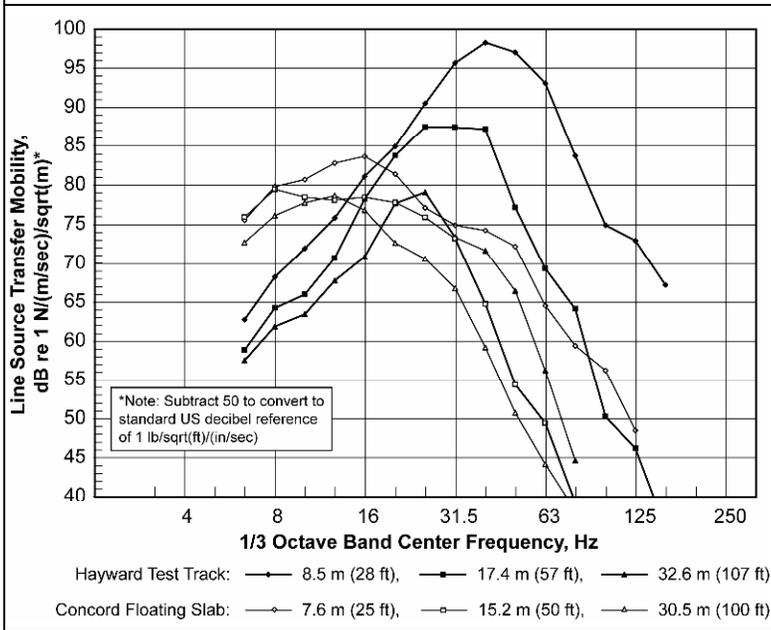
Fig. 4. Line source transfer mobilities measured at the Hayward test track and Concord floating slab test sites.

Fig. 4 shows the line source transfer mobilities measured at the two sites. As is clear from Fig. 4, the two test sites have very different subsurface conditions which are partially responsible for the differences in train vibration. The transfer mobility at the Hayward Test Track site has much more high frequency content and less low frequency content than at the Concord site. Combining the train vibration from Fig. 3 and the transfer mobility from Fig. 4 gives the force densities in Fig. 5. The force density spectra shown in Fig. 5 are the average results from the seven measurement positions at each test site. The seven force density spectra curves from each test site were relatively tightly grouped and usually varied over a range 5 dB or less.

Note that the transfer mobility for the Hayward Test Track was measured from the toe of the ballast and for the Concord floating slab was measured from the concrete slab under the floating slab. This means that the concrete slab is incorporated into the transfer mobility at the floating test site.

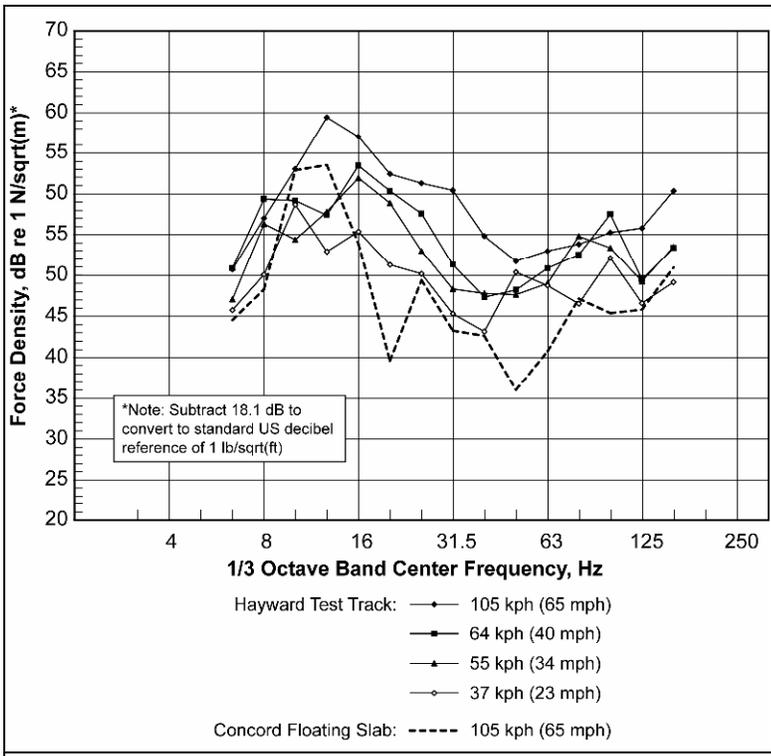
Fig. 5. Derived force densities for Hayward Test Track and Concord floating slab.

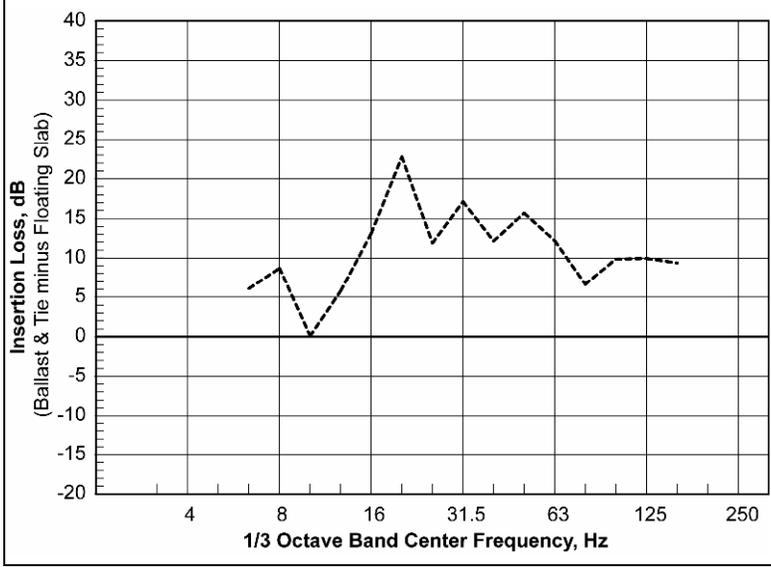
Fig. 6. Measured insertion loss for Concord floating slab compared to Hayward test track, 65 mph trains (positive insertion loss indicates improvement). The values at frequencies greater than about 40 to 50 Hz are questionable because of the low vibration amplitudes at the floating slab test site at these frequencies.

The insertion loss for the Concord floating slab is shown in Fig. 6, where insertion loss is estimated as the difference in the average force densities. Because of the very low vibration levels for the floating slab measurements at frequencies above 40 to 50 Hz, we suspect that the curve in Fig. 6 understates the high-frequency insertion loss. Also, the positive insertion loss in the 6.3 and 8 Hz 1/3 octave bands results is suspect since one would expect it to be zero or negative due to the isolation system resonance. However, the minimum in the 10 Hz band may be attributable to the slab resonance. The overall conclusion is that the Concord floating slab is performing very well over a fairly broad frequency range.

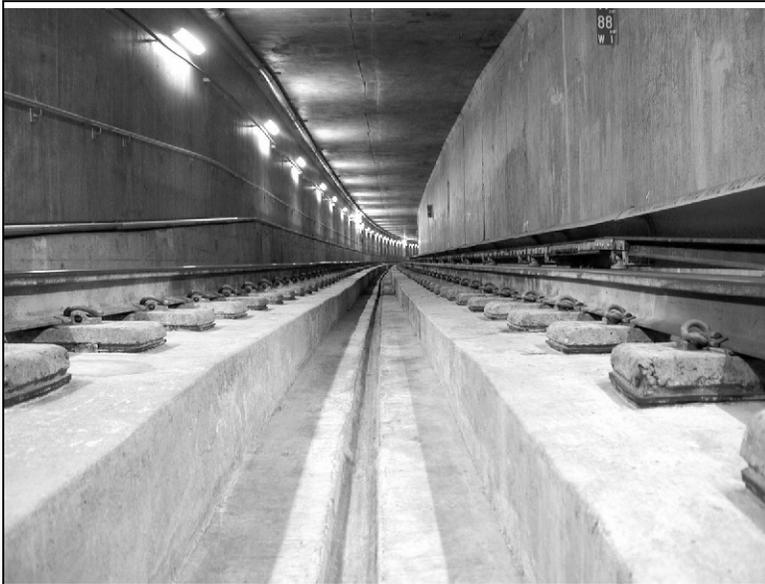
Fig. 7. Photograph of resiliently supported half ties (LVT track) in the San Francisco Airport Extension subway.

as the direct fixation track, and continuous floating slab with a design vertical resonance frequency of 10 Hz. Fig. 7 is a photograph of the LVT track and Fig. 8 is a photograph of the floating slab section.

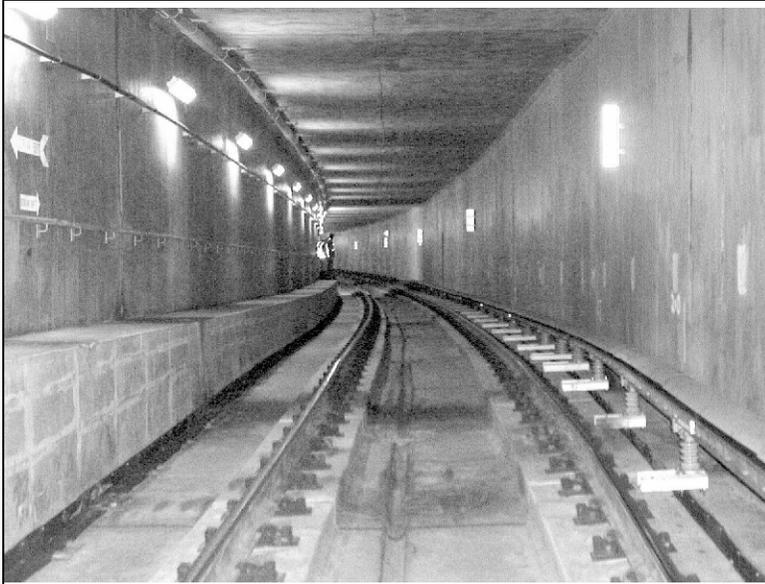
Fig. 8. Photograph of continuous floating slab track section in the San Francisco Airport Extension subway. Because there are no gaps between the floating slab and the subway invert larger than a few inches, impact testing from the invert to the surface was not feasible for this section of track.

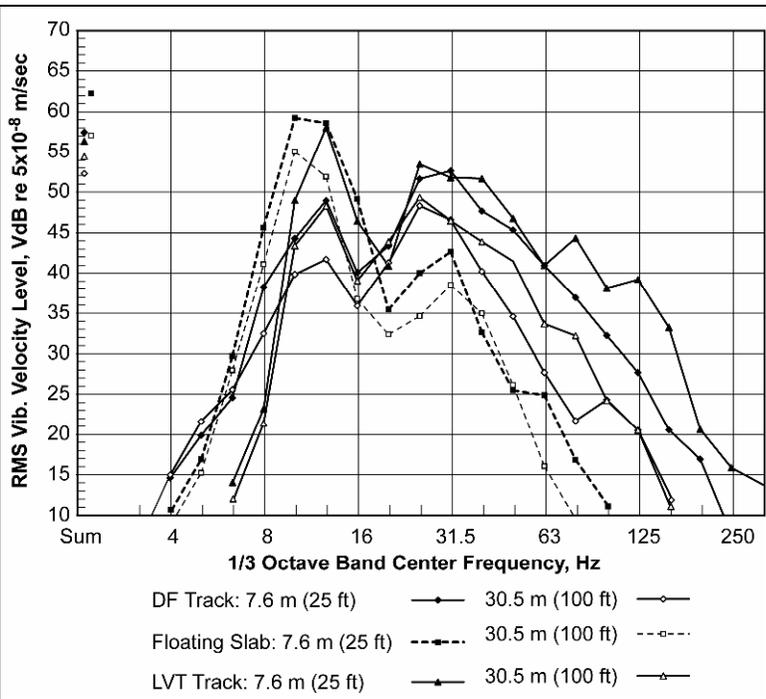
Fig. 9. Average vibration velocity levels measured at the ground surface above the San Francisco Airport Extension subway. All measurements were in the same general area of South San Francisco. Trains speeds are typically 65 mph in this area.

Fig. 9 shows the vibration spectra measured at 25 and 100 feet from the track centerline (horizontal distance). The floating slab clearly has a dramatic effect (improvement) at frequencies greater than 16 Hz; however, because of the increased vibration energy at low-frequencies, the overall vibration levels are higher at the floating slab sections than at the direct fixation and LVT track sections. In looking at the vibration results at the

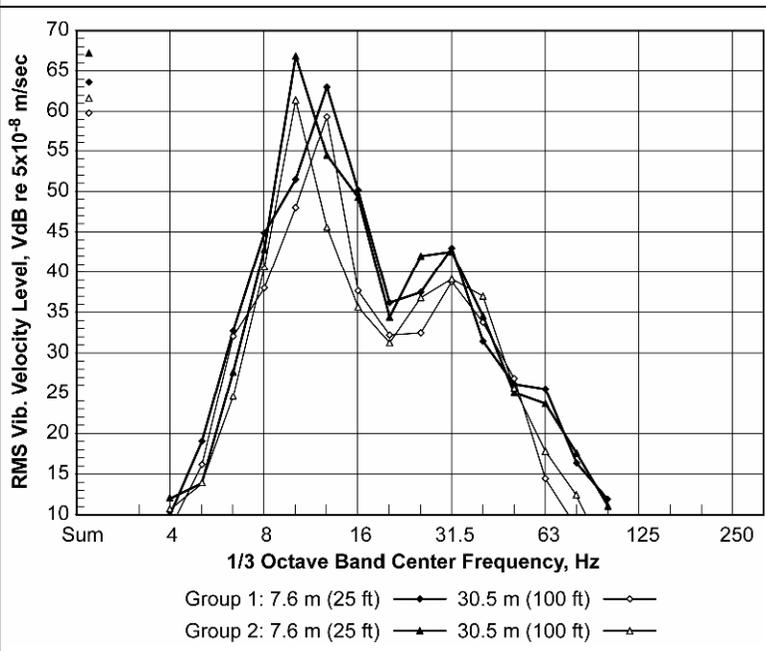
Fig. 10. Averages for two groups of trains at SFO Airport extension floating slab section.

floating slab section, we noticed that most of the trains either had a strong peak in the 10 Hz 1/3 octave band or the in the 12 Hz 1/3 octave band. We suspect that this peak is related to the wheel rotation frequency interacting with the floating slab resonance. Of a total of 11 trains, five were clearly in Group 1 (12 Hz) and four were clearly in Group 2 (10 Hz). There were two trains that did not fall into either group, possibly because of changing speeds as the trains passed the measurement site.

BART trains have 30 inch diameter wheels, which means that at 65 mph the wheel rotation frequency is 12 Hz. The programmed speed for trains in the test section of the SFO subway is 65 mph. It certainly appears that the wheel rotation frequency at 65 mph and the floating slab resonance, which was designed to be 10 Hz, are interacting to amplify vibration at this frequency. At 54 mph the wheel rotation frequency is 10 Hz. It appears that the four Group 2 trains were travelling about 10 mph less than the programmed speed of 65 mph, and that there was a strong interaction between the wheel rotation frequency and the floating slab resonance frequency. Note that the vibration at the Concord floating slab did not have the same shape peak; perhaps because there is enough separation between the design resonance frequency of 8 Hz and the 12 Hz wheel rotation frequency (normal train speed at the Concord floating slab is 65 mph).

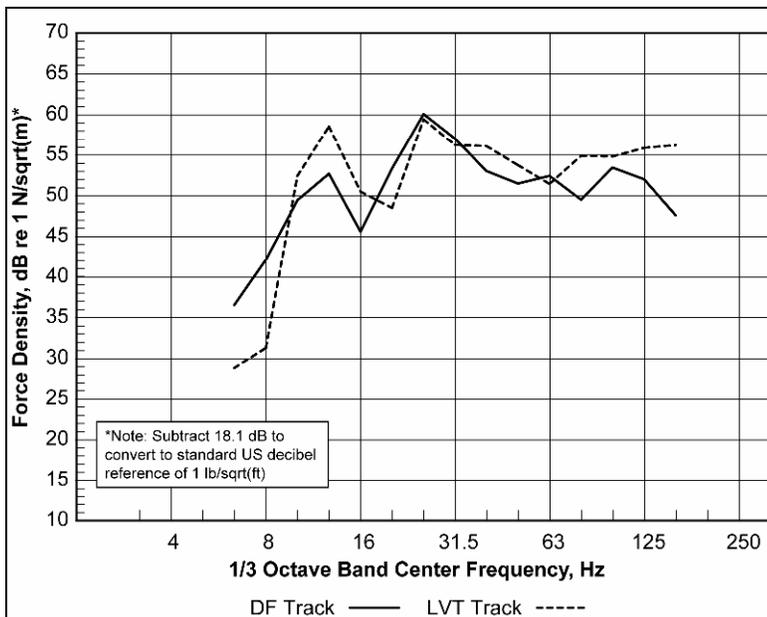
Fig. 11. Measured force density for direct fixation and LVT track, SFO Airport subway.

The force densities derived for the direct fixation and LVT track in the SFO subway are shown in Fig. 11. Although there are differences of 0 to 3 dB at frequencies of 20 Hz and above, these do not look to be a consistent pattern that could be attributed to the differences in the vibration properties of the track support systems. There are 0 to 5 dB differences below 20 Hz with more vibration at LVT track between 10 and 16 Hz and less vibration at LVT track at lower frequencies. Given that there is no apparent mechanism by which the two track forms would have different low frequency vibration, we suspect that the low frequency differences are unrelated to the track fastener systems.

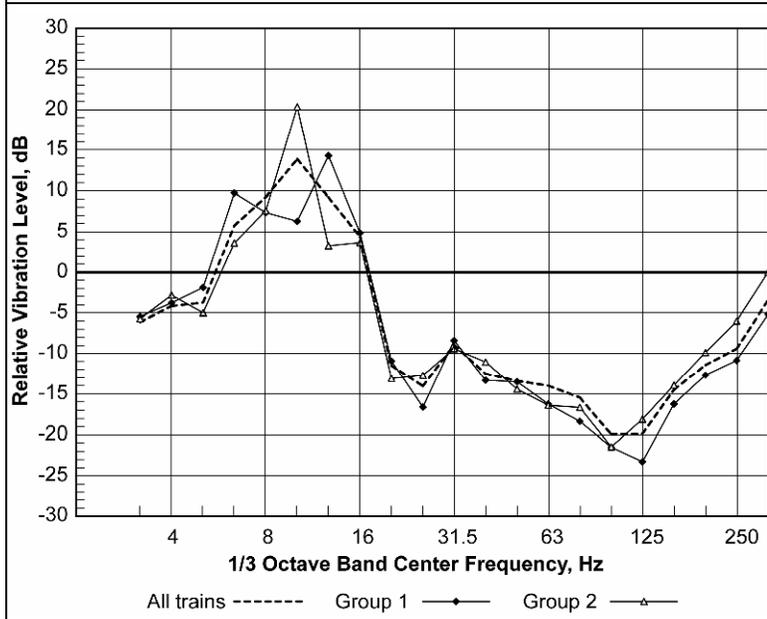
Fig. 12. Comparison of train vibration from direct fixation and floating slab test sections, SFO Airport subway. Shown are the average differences of floating slab vibration minus direct fixation vibration (a negative number implies an improvement by the floating slab).

The difference between the average vibration levels at the floating slab and direct fixation sections of the SFO subway are shown in Fig. 12. The fairly dramatic reduction at frequencies of 20 Hz and greater is much as expected. Note that the vibration levels at 63 Hz and above were quite low at the floating slab section and the differences at frequencies greater than 63 Hz may be understating the effectiveness of the floating slab. The strong effects of the 10 and 12 Hz peaks in the floating slab vibration spectrum are very evident in Fig. 12. It is clear from this figure that attention should be paid to the potential interaction of the wheel rotation frequency and the floating slab primary resonance when designing floating slabs.

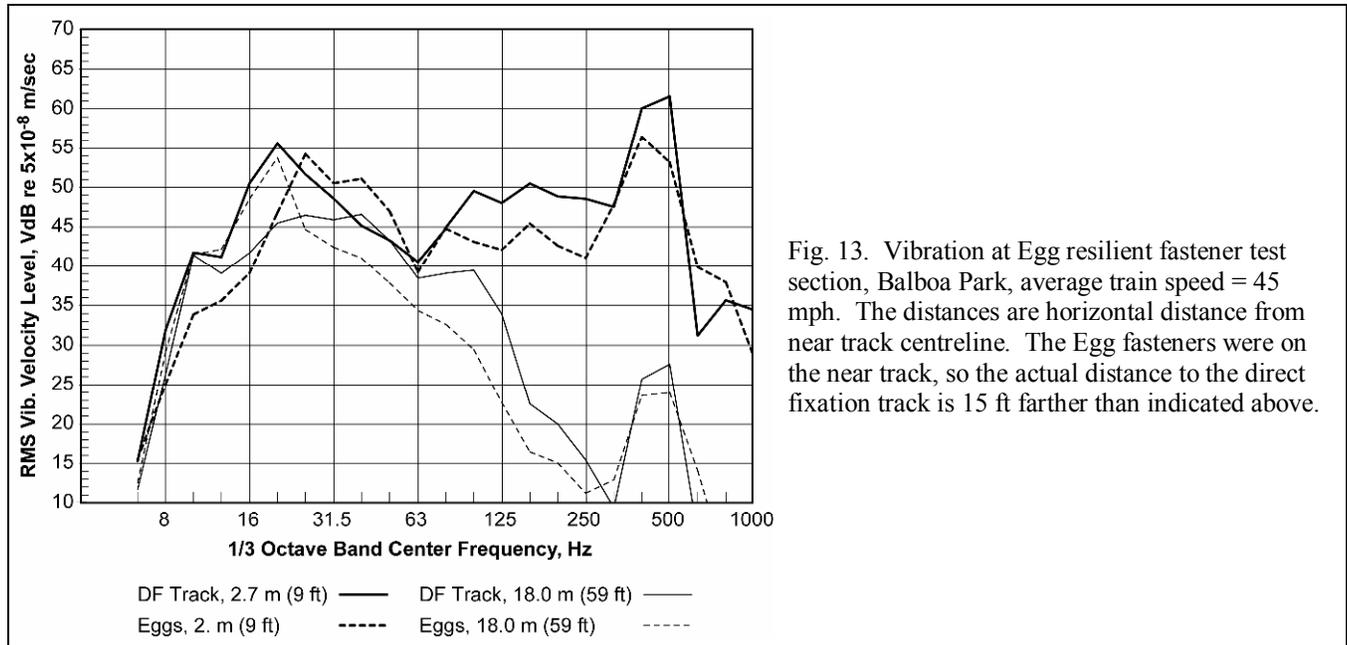
Fig. 13. Vibration at Egg resilient fastener test section, Balboa Park, average train speed = 45 mph. The distances are horizontal distance from near track centreline. The Egg fasteners were on the near track, so the actual distance to the direct fixation track is 15 ft farther than indicated above.

The average vibration levels measured at two distances are shown in Fig. 13. The frequency range on this plot has been extended to 1000 Hz so that the effect of the rail corrugation can be seen. Typical corrugation wavelength at BART is 1.5 to 2 inches. At train speeds of 45 mph, this translates to a frequency of 430 to 570 Hz. The strong peak from corrugation is clear in all of the spectra in the 400 and 500 Hz 1/3 octave bands.

Because of the strong effect of the corrugation, we are hesitant to draw too many conclusions from Fig. 13 about the effectiveness of the Egg fasteners. Note that the curves for the two track sections are not directly comparable since the Eggs were on the near track and the old direct fixation fasteners were on the far track. Accounting for the track separation, it appears from Fig. 13 that the Egg fasteners are providing 5 to 8 dB vibration attenuation at frequencies of 31.5 Hz and higher
